Manhole Inspection Summary

Manhole # S41AA_005MH

Insp Date: **12/13/07 3:46 PM**

Location Address: **e.madison st**

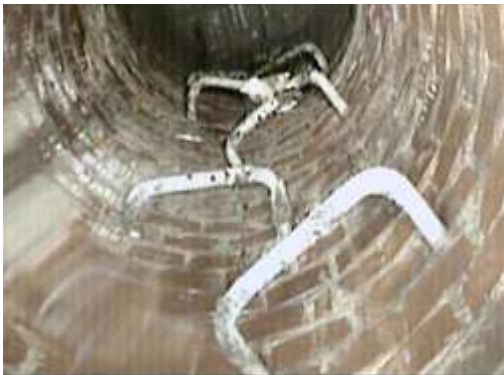
Defect 1

Count: **13** Missing: **1** ☒ **Corroded**

steps

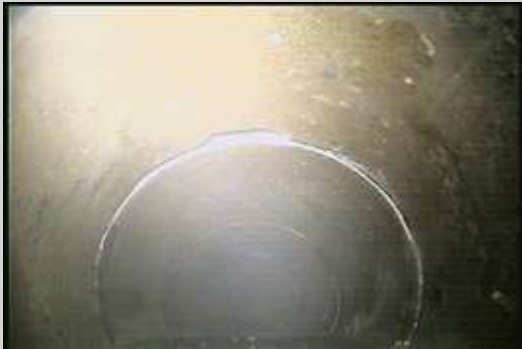
12 O'Clock Outflow

18 in. Circular Gravity Sewer
Pipe Out @ 12 O'Clock

Invert Depth: **19.70** (ft.) Flow Characteristics: **Turbulent**

Infiltration: **None** Pipe Seal Cond: **Unknown**

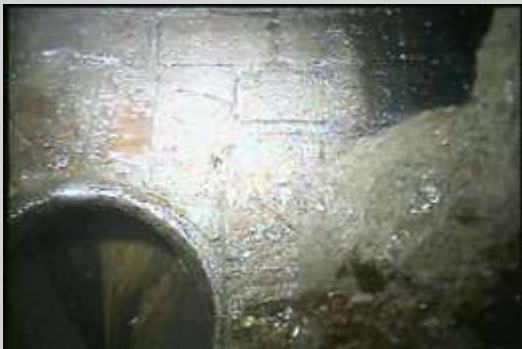
3 O'Clock Inflow

8 in. Circular Gravity Sewer
Pipe In @ 3 O'Clock

Invert Depth: **19.50** (ft.) Flow Characteristics: **Fast**

Infiltration: **None** Pipe Seal Cond: **Unknown**

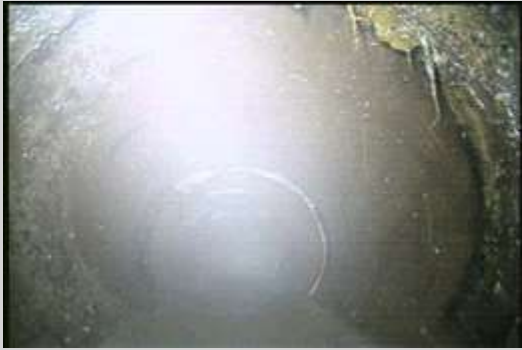
6 O'Clock Inflow

18 in. Circular Gravity Sewer

Pipe In @ 6 O'Clock

Invert Depth: **19.40** (ft.) Flow Characteristics: **Turbulent**

Infiltration: **None** Pipe Seal Cond: **Unknown**

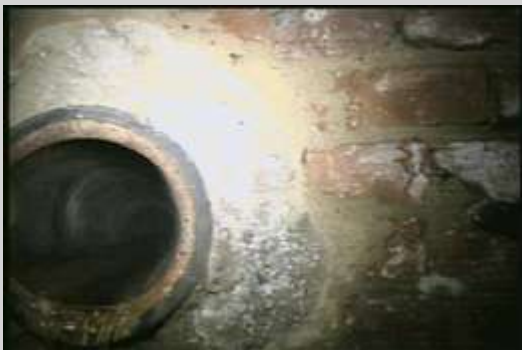
8 O'Clock Inflow

8 in. Circular Gravity Sewer

Pipe In @ 8 O'Clock

Invert Depth: **12.60** (ft.) Flow Characteristics: **Fast**

Infiltration: **None** Pipe Seal Cond: **Unknown**

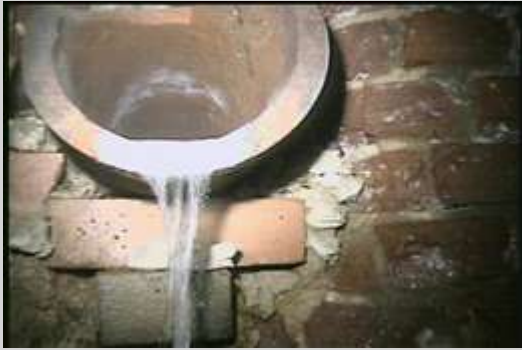
9 O'Clock Inflow

8 in. Circular Gravity Sewer

Pipe In @ 9 O'Clock

Invert Depth: **12.60** (ft.) Flow Characteristics: **Fast**

Infiltration: **None** Pipe Seal Cond: **Unknown**
